1010 LAKE STREET

PARKING GARAGE CONDITION ASSESSMENT

Project Number 23028.00
April 23, 2023

Re: 1010 Lake Street Parking Garage - Condition Assessment
CDG Project #23028.00

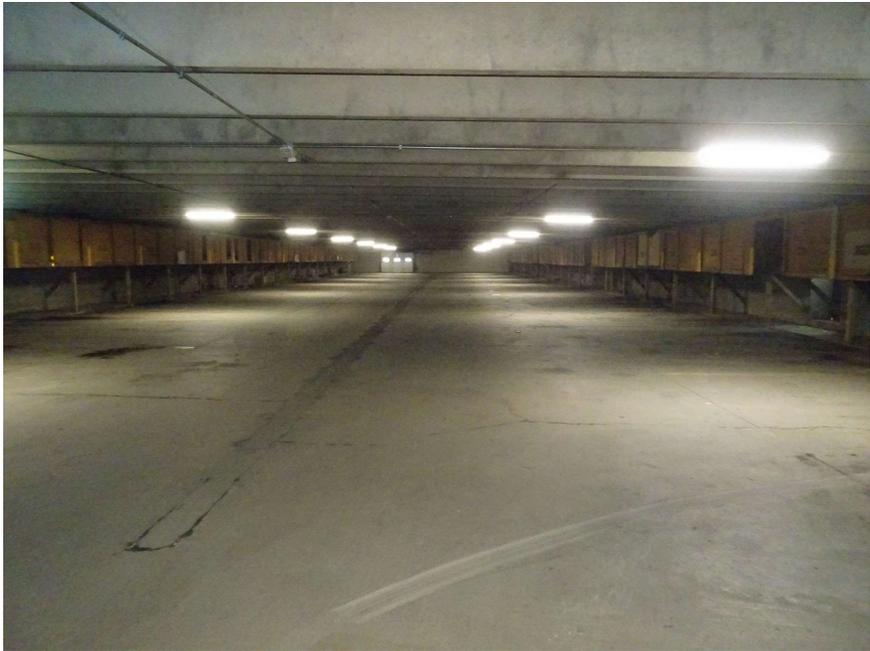
OBSERVATION	REFERENCE PHOTO
<p>Precast Double Tees/Slabs</p> <p>1. Precast concrete double tees clear span the width of the east and west sides of the garage, and are in overall good condition, with isolated areas of deterioration.</p>

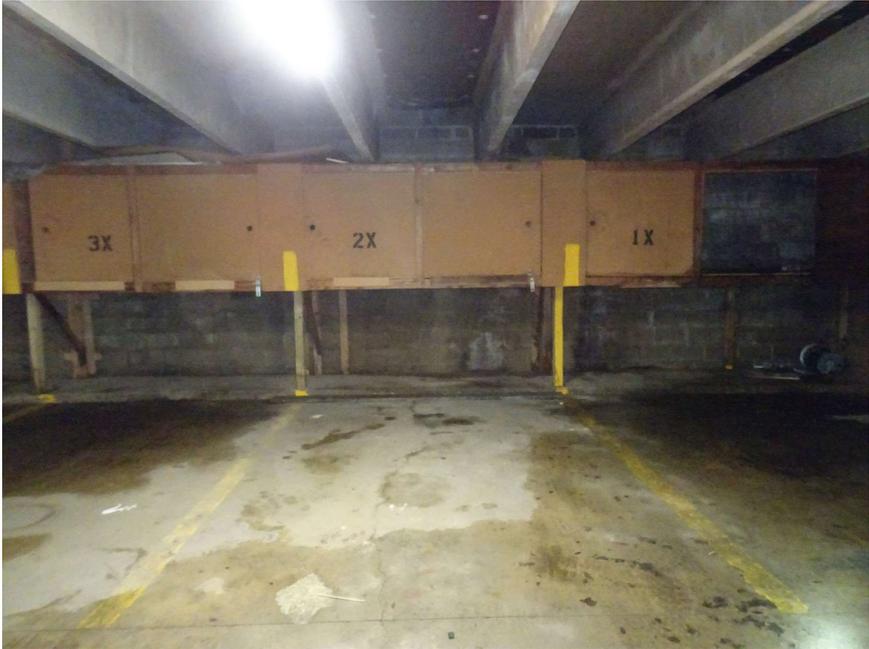
OBSERVATION	REFERENCE PHOTO
2. The double tees bear on CMU walls at the center and exterior walls.

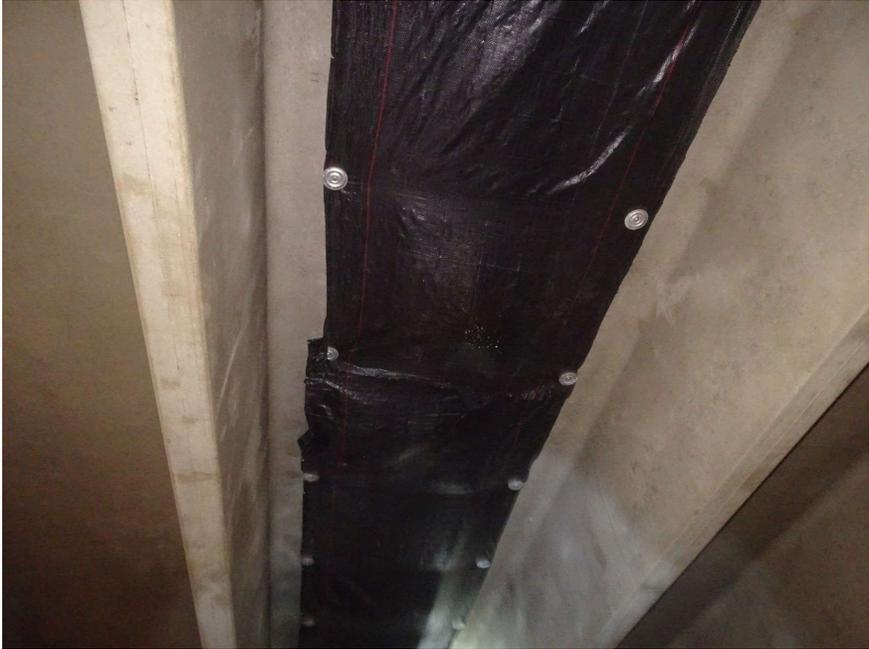
A photograph of an underground parking ramp. The ceiling consists of concrete double tees supported by a wall of concrete masonry units (CMU). The wall has three sections labeled '3X', '2X', and '1X' from left to right. The floor is concrete with yellow painted lines and some water stains.
3. Fabric was installed beneath the joints between the double tees. Note that fallen concrete is evident in the bulged fabric, along with water seepage.

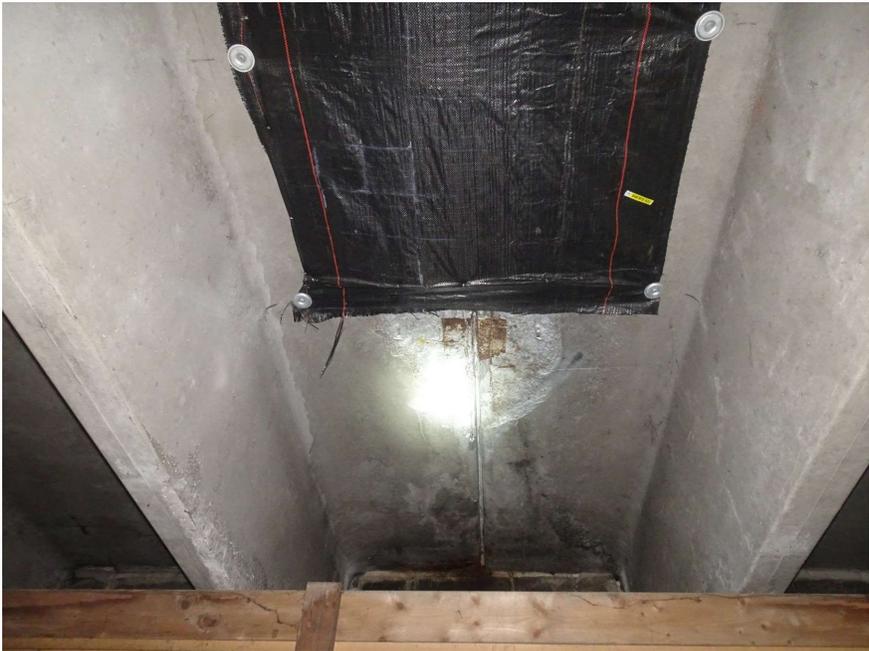
OBSERVATION	REFERENCE PHOTO
4. The observed flange connectors on the upper level double tees are in poor condition, with corrosion and spalling concrete evident.

Most of the obvious deterioration in this garage appears in the failure of slab flange weld plates and sealant joints. Flange connector plates serve to connect adjacent double tees, ensuring that they act uniformly as one system. Without the plates, adjacent double tees deflect differently under loading, causing excessive wear and tear on the sealant joints. The connector plates also serve to provide a diaphragm to distribute lateral loads, such as wind, and ensure structural stability of the garage. Based on the observations indicated above, it is evident that a significant number of connector plates have deteriorated.

All spalls and delaminations on the top side of the double tee flanges should be identified and repaired. All deteriorated or failed connector plates should be repaired or replaced.

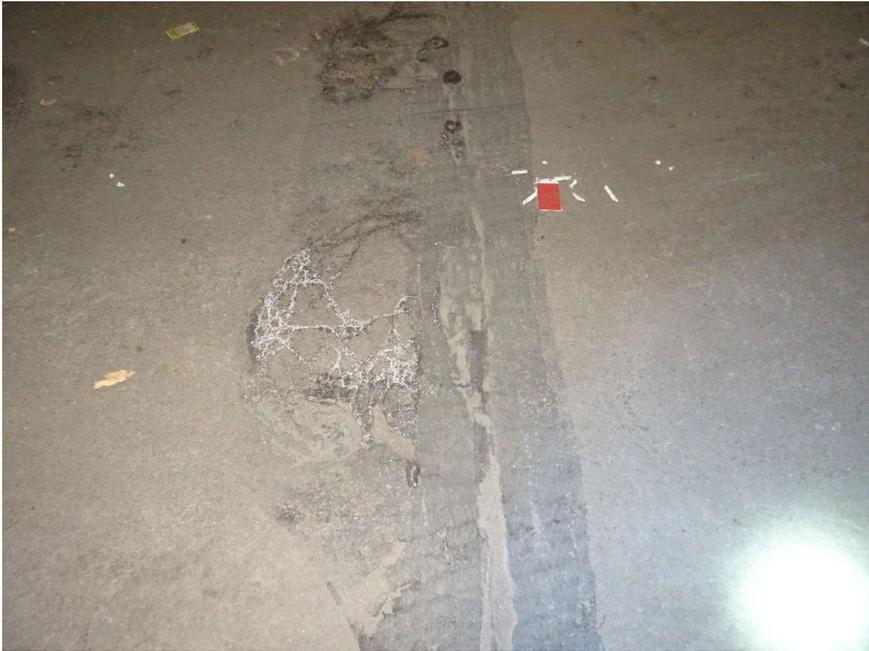
5. Spalling concrete is evident at the flange connectors on the upper level.

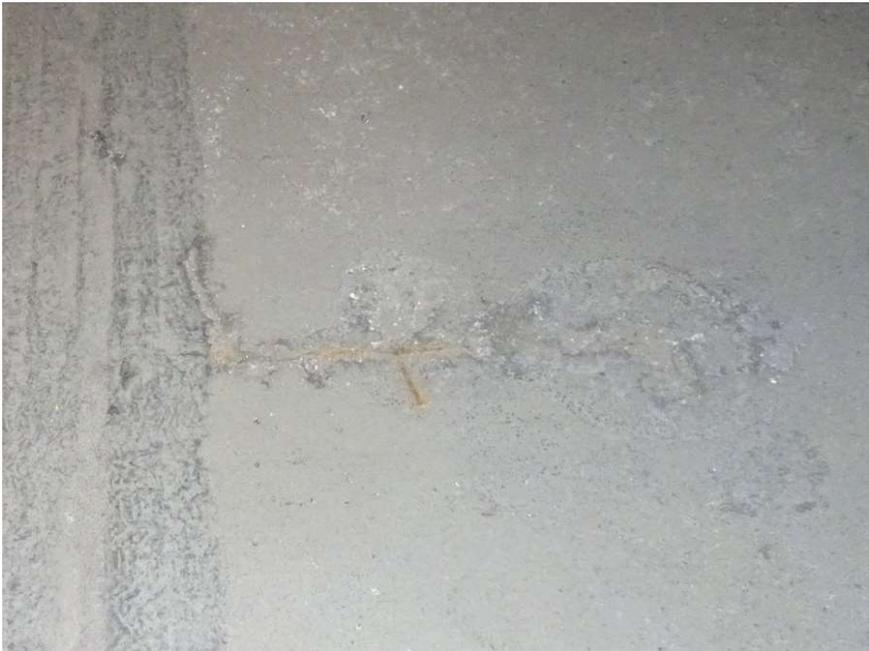
OBSERVATION	REFERENCE PHOTO
6. Spalling is evident on the upper level double tee flanges in isolated locations, exposing the steel wire mesh. This is a poor condition.

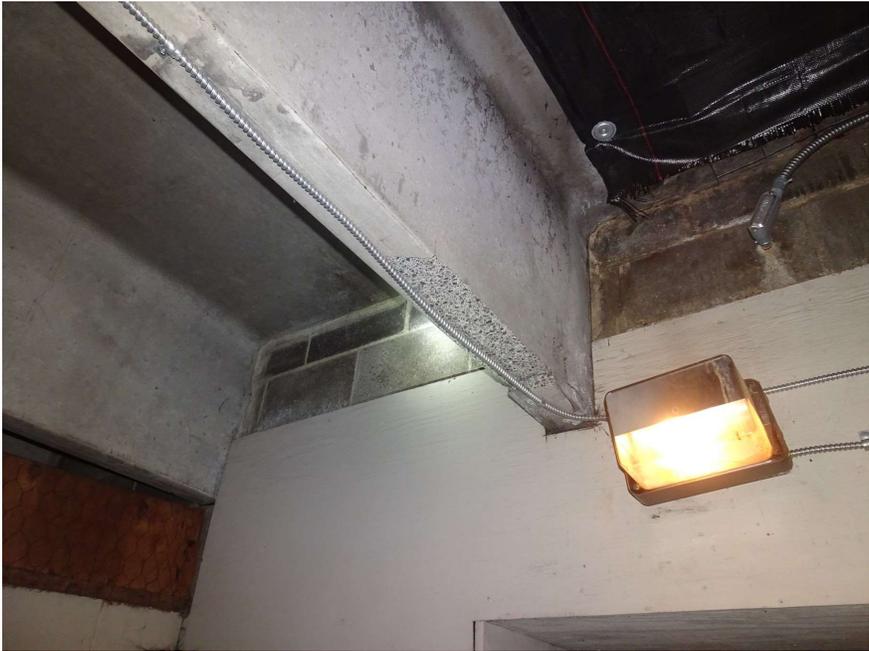
7. Minor spalling is evident at the bearing ends of some double tees.

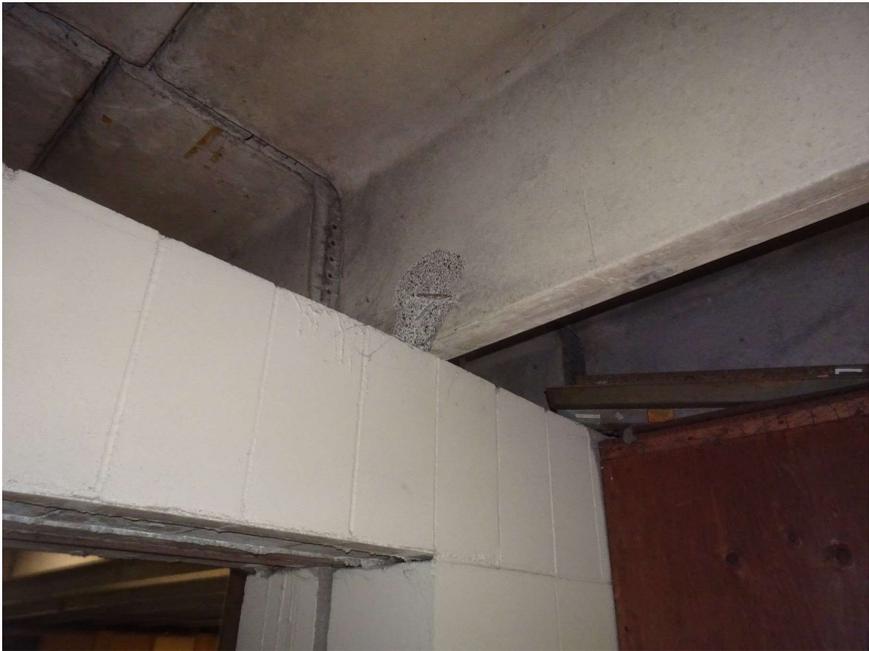
OBSERVATION	REFERENCE PHOTO
8. Minor spalling is evident at the bearing ends of some double tees.

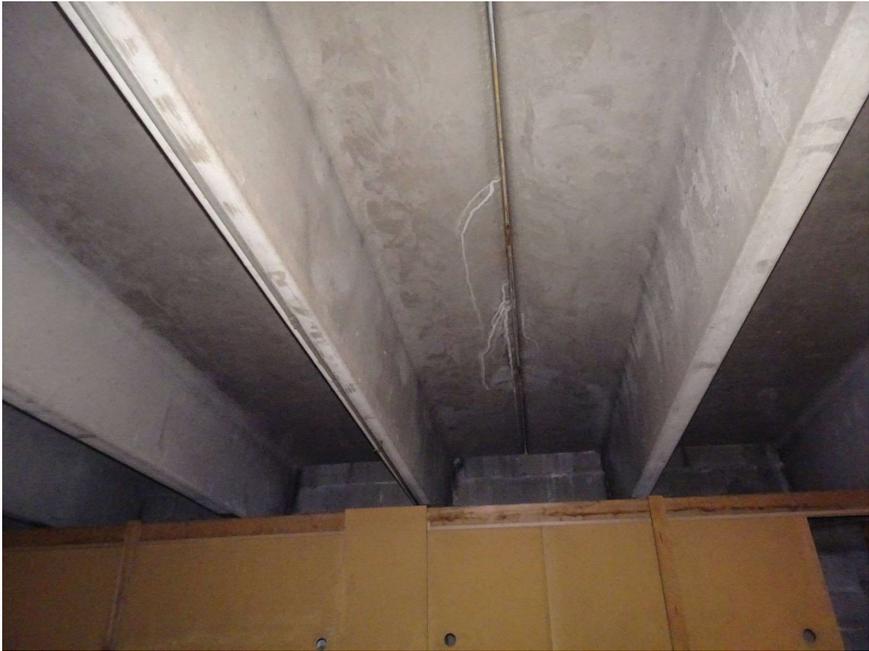
9. Stains from water infiltration is evident on the double tees of the roof, but no deterioration was observed.

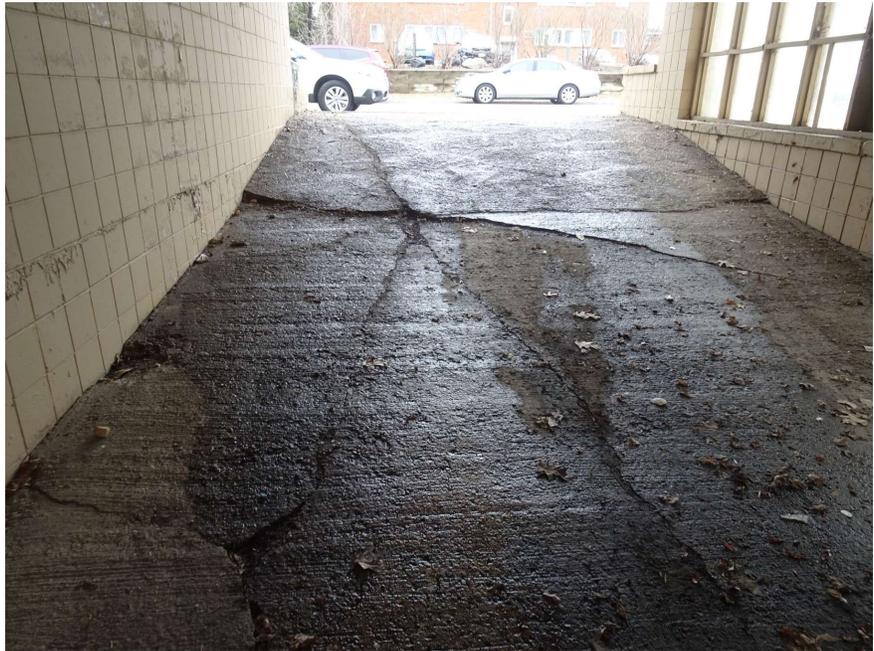
10. The concrete slab on grade on the entrance ramps is cracked and in poor condition. This is not a structural concern.

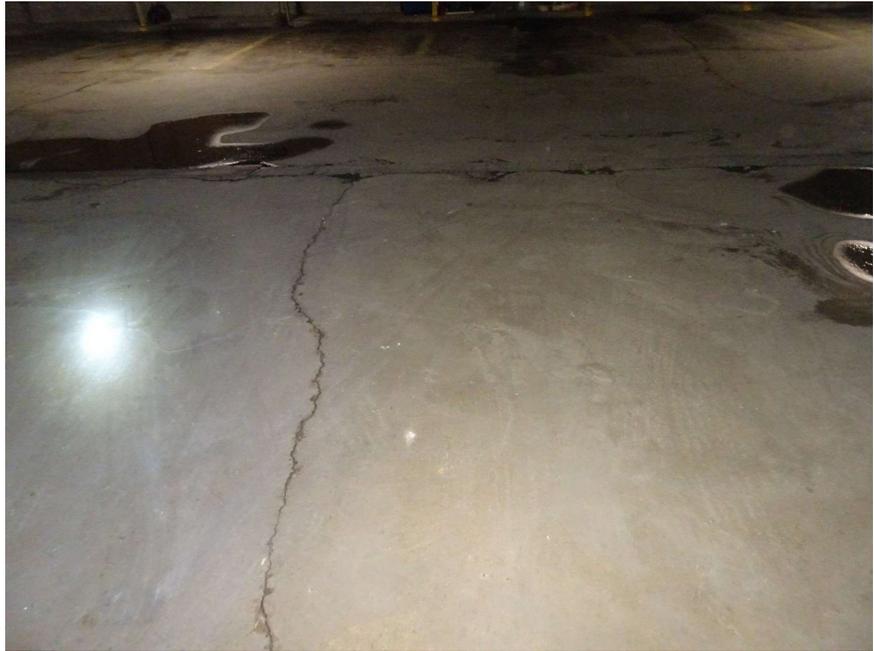
11. The concrete slab on grade on the lower level is cracked and in poor condition. This is not a structural concern.

The concrete slab on grade on the lower level is in overall good condition with some localized cracks and small spalls. This condition is not a structural issue, but should be repaired if a tripping hazard is created.

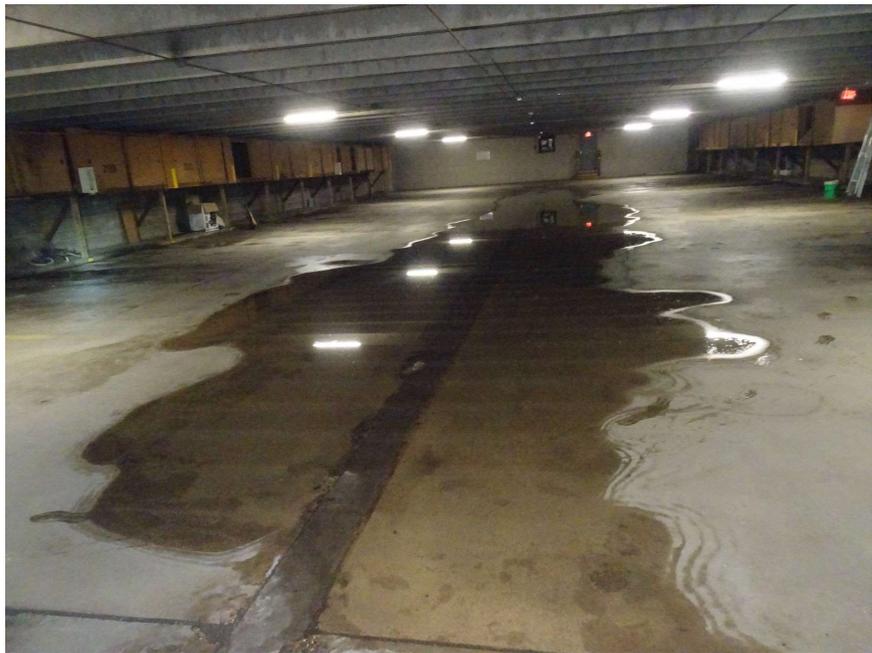
12. Ponding water is evident on the lower level, likely due to clogged drains.

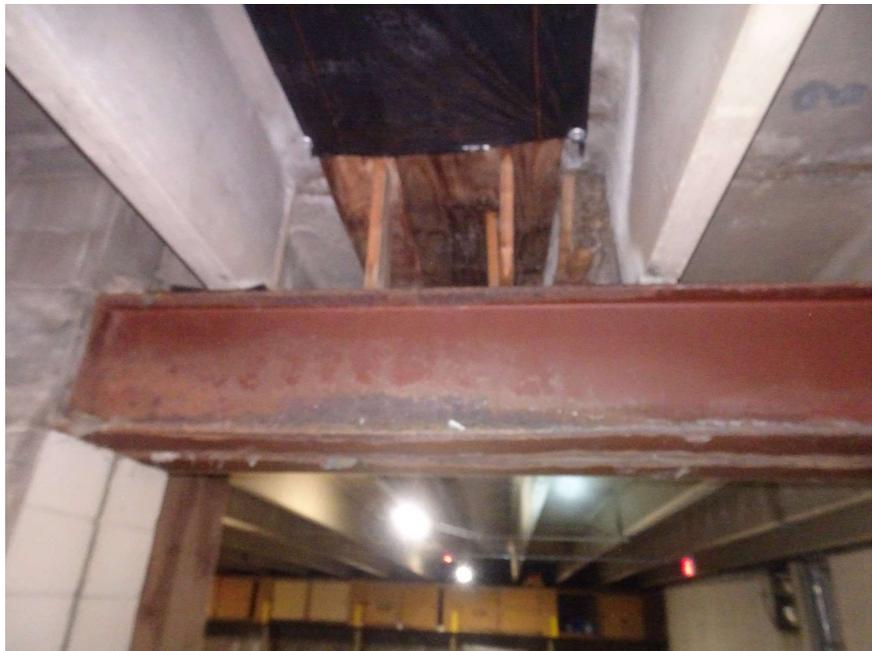
13. Steel beams are used to support the double tees at the openings of the center wall. The steel beams have some corrosion, but are performing well and in overall good condition.

Although the steel beams have some corrosion, they remain in good structural condition and are able to support the intended loads. The water infiltration above the beams needs to be remediated prior to correcting the corrosion issue.

The corrosion on the steel beams should be removed and the beams repainted after the water seepage from above is corrected.

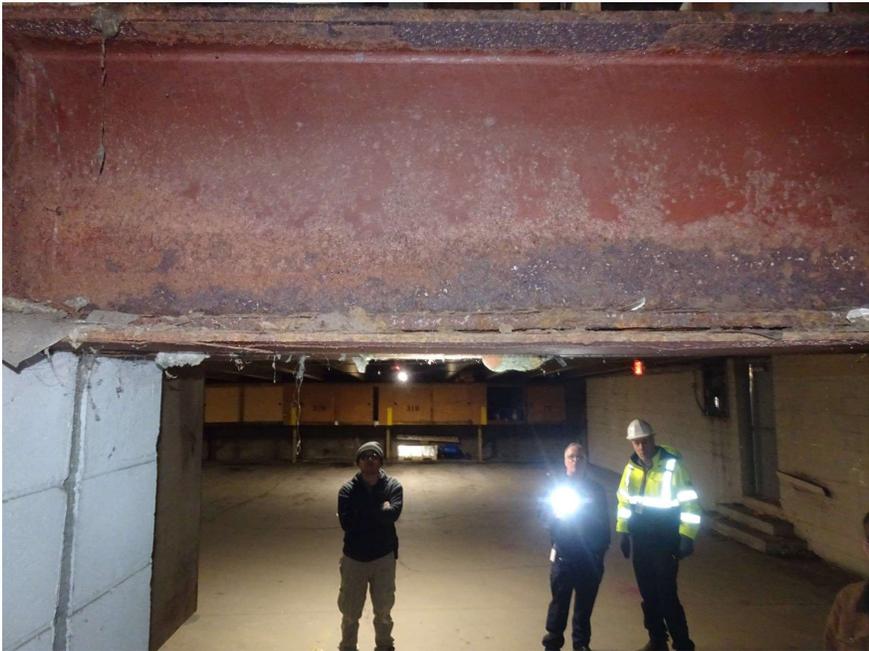
OBSERVATION	REFERENCE PHOTO
<p>14. The bottom plate on the steel beams is buckled due to corrosion. This is not a structural concern, as the bottom plate is not required for the integrity of the beam. The bottom flange of the beam is in good condition, with minor corrosion.</p>

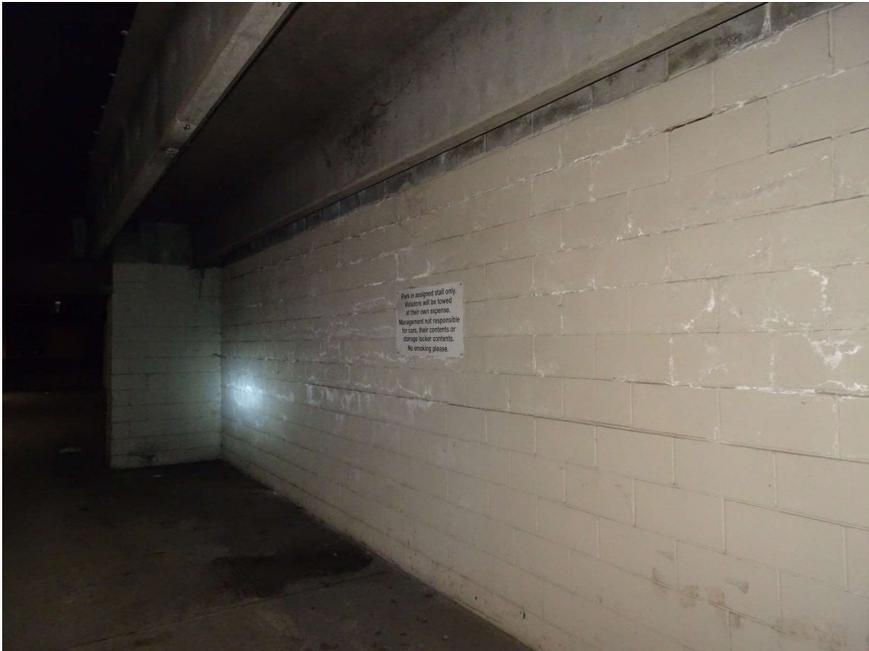
<p>Walls</p>	
<p>15. The CMU walls are in overall good condition, with some minor cracking evident.</p>

The CMU walls are in overall good condition, with some localized cracking and deterioration. The water infiltration issues should be corrected prior to repairs.

Any deteriorated CMU should be repaired after the water seepage is corrected.

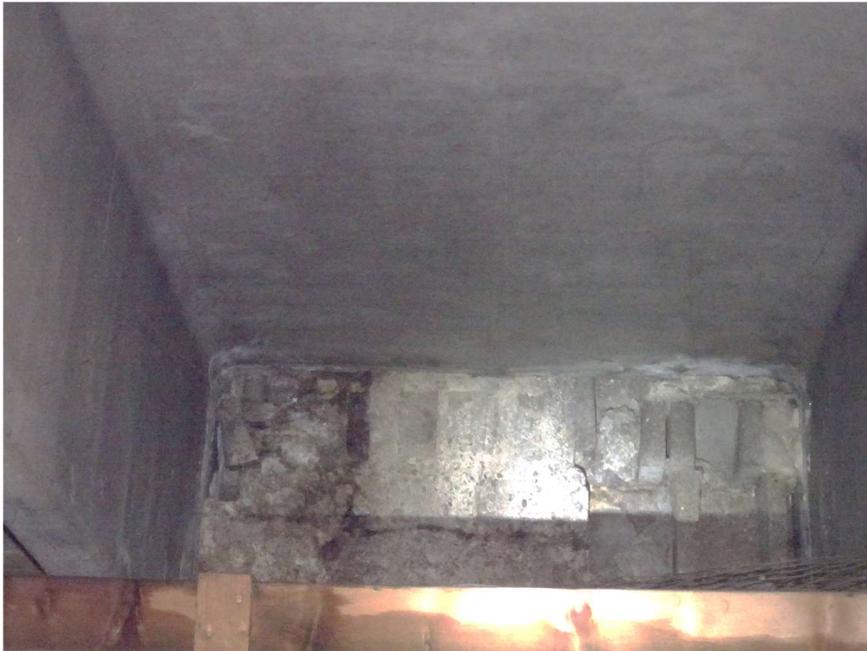
OBSERVATION	REFERENCE PHOTO
<p>16. Some deterioration of the CMU walls is evident on the exterior walls.</p>

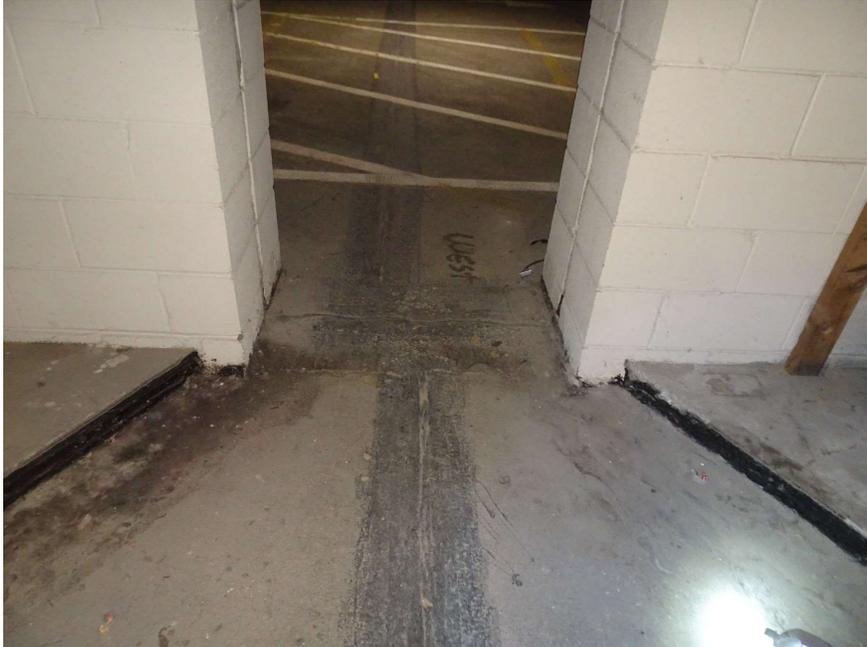
A photograph showing a section of a concrete masonry unit (CMU) wall. The wall is heavily deteriorated, with significant crumbling and loss of material, particularly in the center. The surface is uneven and appears to be covered in a layer of dust or debris. The lighting is dim, highlighting the texture and damage of the masonry.
<p>Waterproof Coatings</p> <p>17. Waterproof coating has been applied over the joints between double tees, and is in overall poor condition.</p>

The joints between the double tees have been covered with some type of waterproof coating, which is in poor condition. This coating should be completely removed and replaced.

The waterproof coating over the double tee joints should be replaced.
