Project B2008772

Re: Structural Evaluation and Testing for Parking Garage
Knollwood West Apartments
1010 Lake Street East
Hopkins, Minnesota

Braun Intertec Corporation is pleased to provide this letter to report the findings of the Structural Evaluation and Testing for the Parking Garage at the Knollwood West Apartments located in Hopkins, Minnesota.

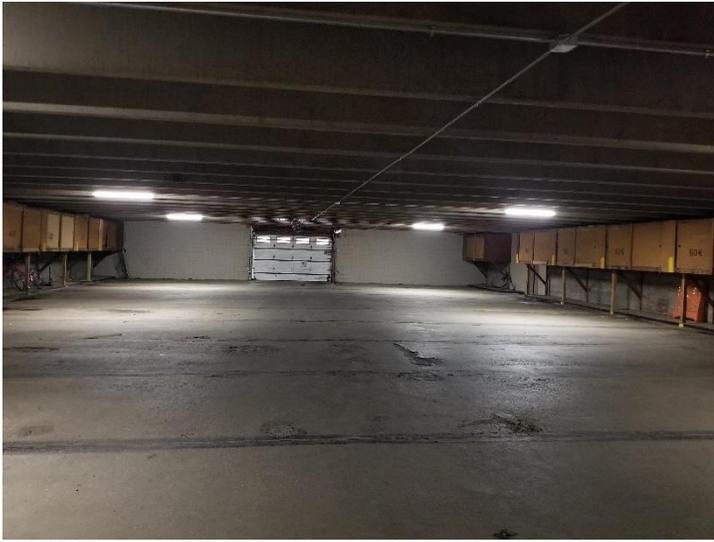
Photograph 1

General Observations (Photograph 1):

- The building was separated into two sections; east and west, with an expansion joint along the middle running north/south.
- Precast planks make up both the upper level floor and the roof which span east/west. The planks were 8 feet wide by 2 feet deep by approximately 60 feet long with 10, 1/2-inch diameter tendons spaced 2 inches on center in each stem and wire mesh reinforcing located

Overall photo from upper level entrance ramp looking north.

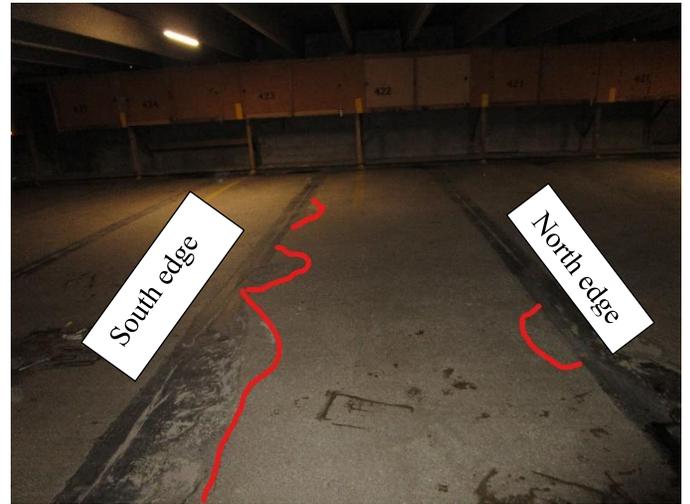
Photograph 2

- Delamination on the top side of the planks was found throughout the garage usually near a joint and in the drive lane (Photographs 2, 5, 9).
- Over half of the planks had spalling along the entire underside of the planks directly adjacent to the joints. The remainder of joints had underside spalling localized at the shear plates of varying locations along the length and varying degree of severity (Photographs 3-4,6-8).

Example of top side delamination: P45 looking west. (Delamination circled in Red)

The top side delamination areas shown in the reference plan that are outside the repair area described above should be chipped out and patched as needed.

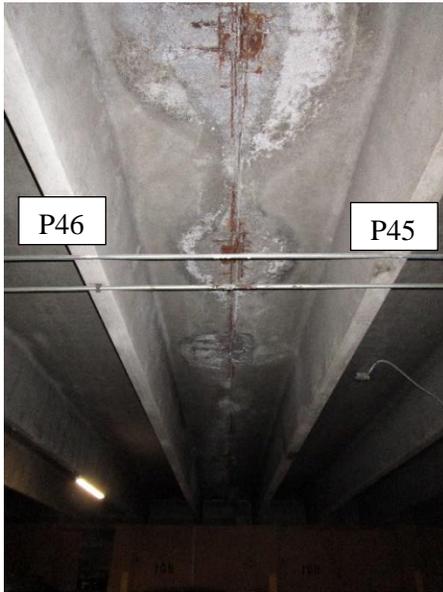
Photograph 3

Example of underside distress: P45 looking west-south edge.

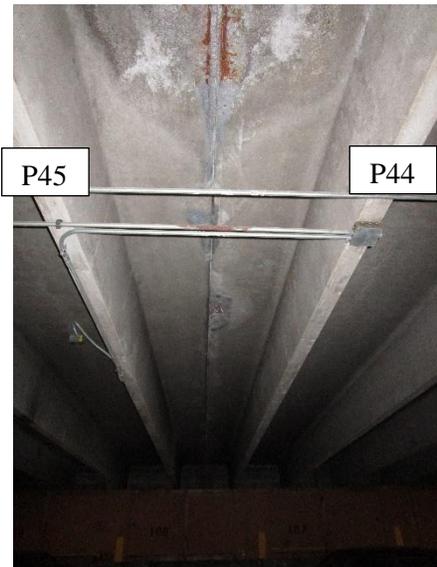
Photograph 4

Example of underside distress: P45 looking west-north edge.

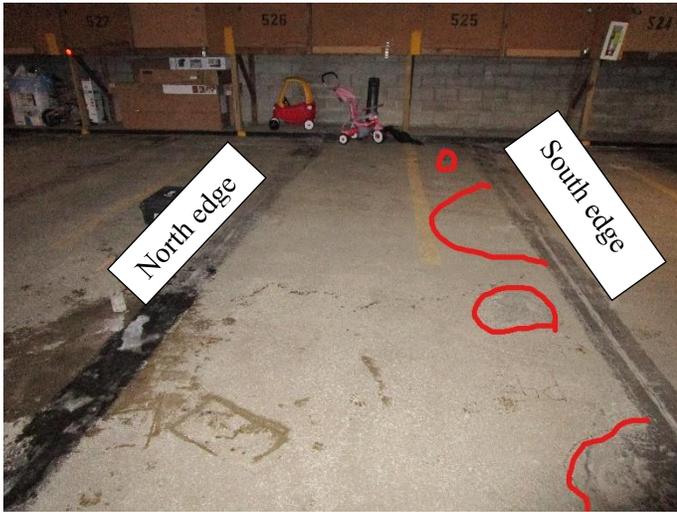
Photograph 5

Example of top side delamination: P45 looking east.
(Delamination circled in Red)

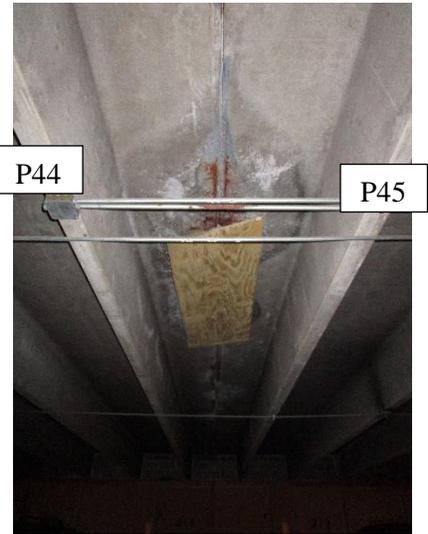
Photograph 6

Example of underside distress: P45 looking east-north edge.

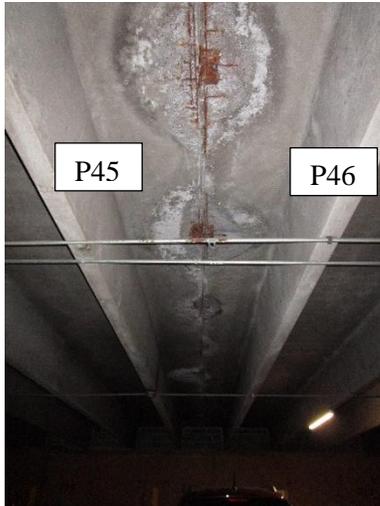
Photograph 7

Example of underside distress: P45 looking east-south edge.

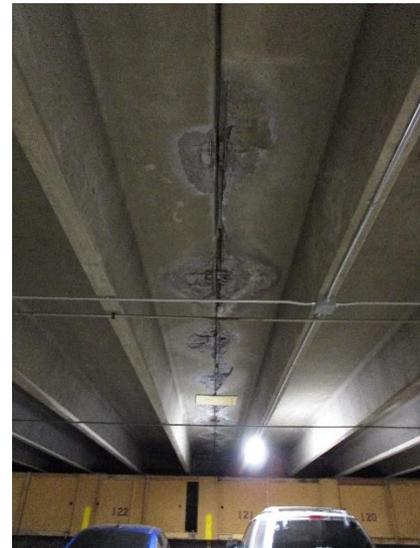
Photograph 8

Typical underside distress: Between P58 and P59 looking west.

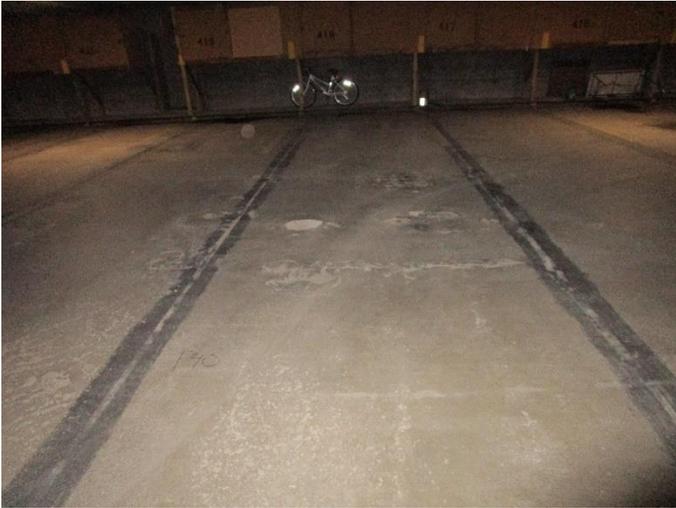
Photograph 9

Panel 40- Looking West, top side delamination across the entire precast panel.

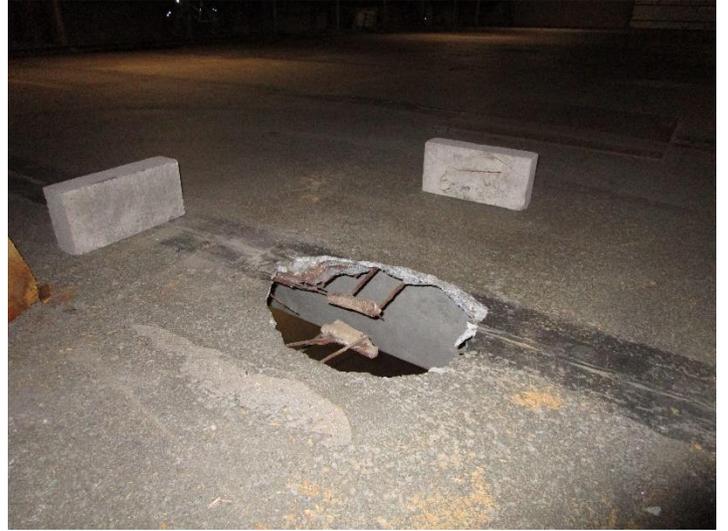
Photograph 10

- The topside delamination and the underside spalling correlated to each other at many of the locations.
- There were two holes in the plank deck (flange) on the west section of the building with multiple other locations with plywood on the underside of the flange likely to prevent falling concrete. These holes were at a shear connector where corrosion of the connector and wire mesh were observed (Photographs 10-12).

Hole between P43 and P44.

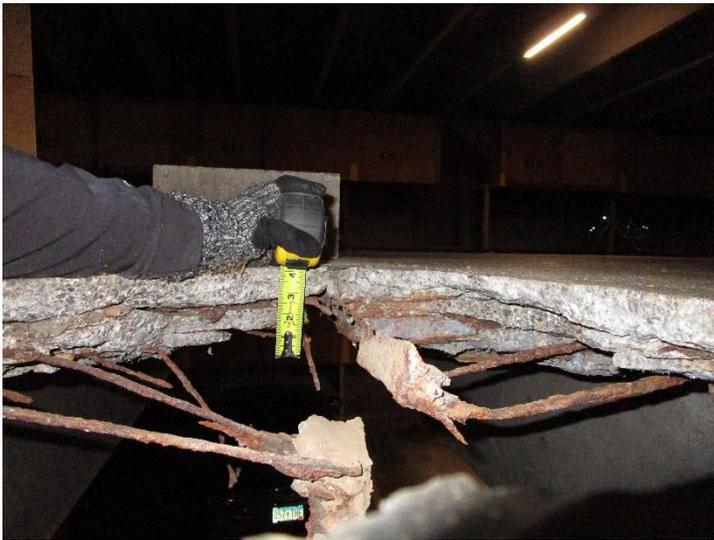
Photograph 11

Close up view of hole, multiple layers of delamination at wire mesh reinforcement.

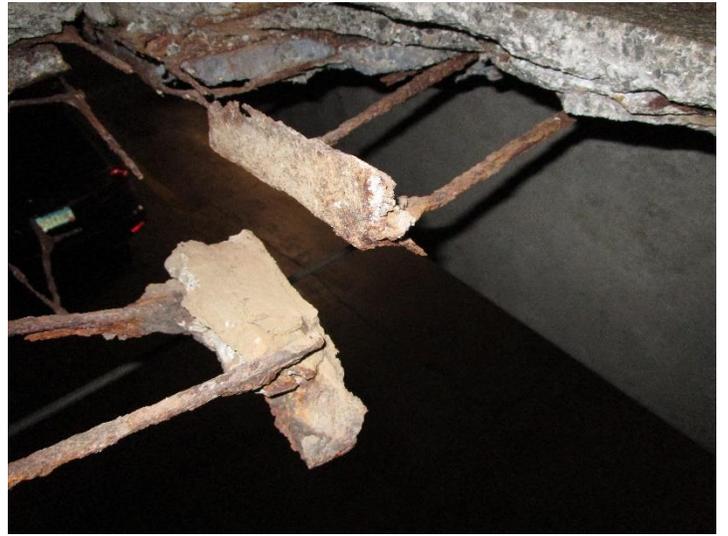
Photograph 12

Corrosion of shear connectors and wire mesh.

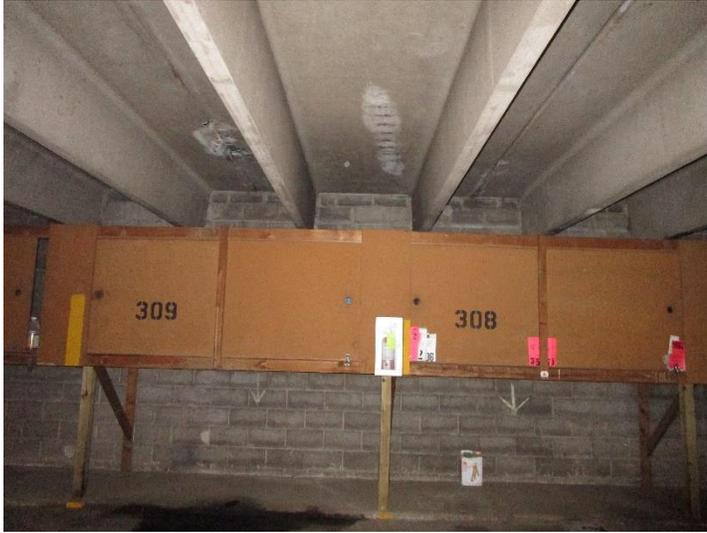
Photograph 13

- Plank P-20 had visible corrosion on the underside at the middle of the plank (Photographs 13-14).

Distress in P20 at midpanel.

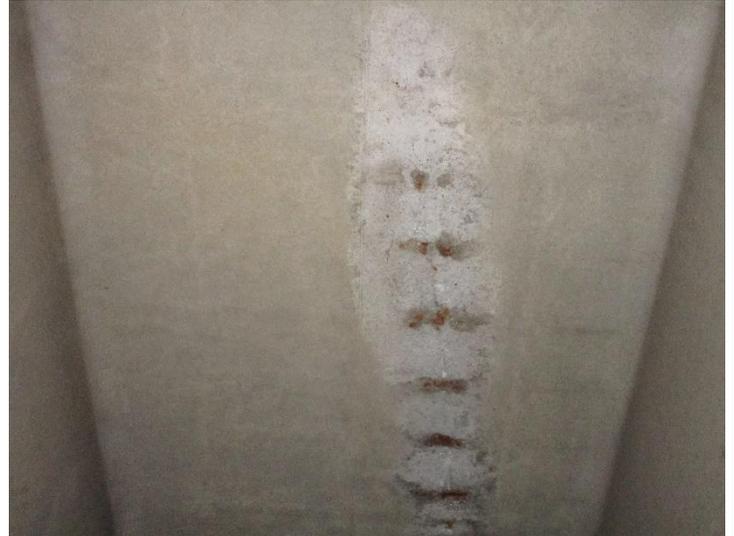
Photograph 14

Close up of Photograph 13.

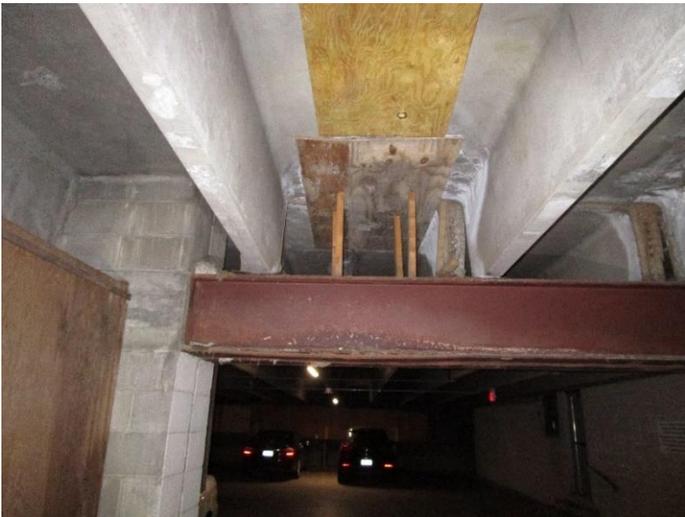
Photograph 15

Overall view of steel lintels at the south drive lane opening.

At the south end of the building, water has been leaking past the precast planks ends which is causing the steel beam lintels to corrode and the pack rust is causing the bottom plate to bow. We recommend the replacement of these steel beams along with repairing the cracks to the CMU bearing area wall. Also, the bond beam in the CMU over the doorway on the north end should be fully replaced.

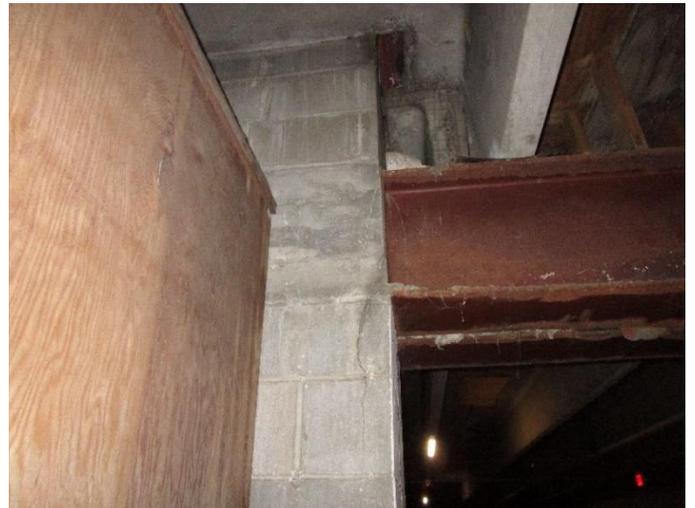
Photograph 16

Cracking in the CMU wall below the steel beam.

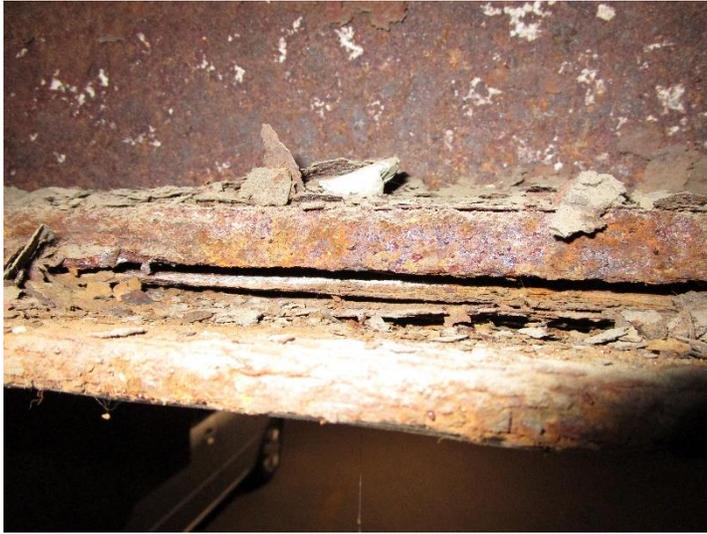
Photograph 17

- A steel beam spanned between the CMU walls at the drive lane between east and west sections of the south end of the building (Photograph 15).
- The CMU wall at the steel beam bearing area was cracking (Photograph 16).
- The steel beam had pack rust between the bottom of the beam flange and the additional bottom plate. This pack rust pushed on the bottom plate making it bow (Photograph 17).
- The precast planks had localized cracking at the bearing point on the steel beam (Photograph 18).

Close up of Photograph 15, pack rust observed.

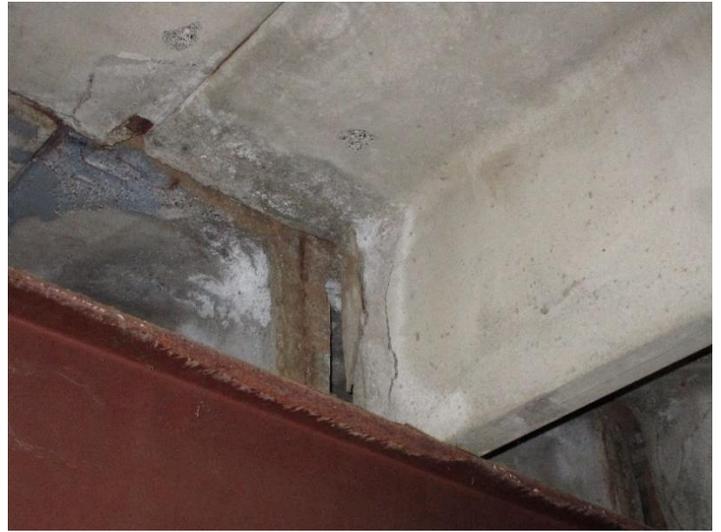
Photograph 18

Cracking at bearing of precast planks over the steel beam.

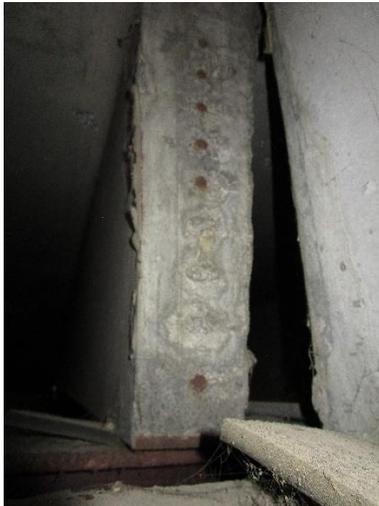
Photograph 19

in the flange section. The double-T stem was 4 inches wide at the bottom and tapers out to 6 1/2 inches wide at the top. The flange was 3 1/2 inches thick. Weld shear plates were spaced at 4 feet on center along the length of the plank (Photograph 19).

End view of reinforcement in the precast plank web above steel lintel.

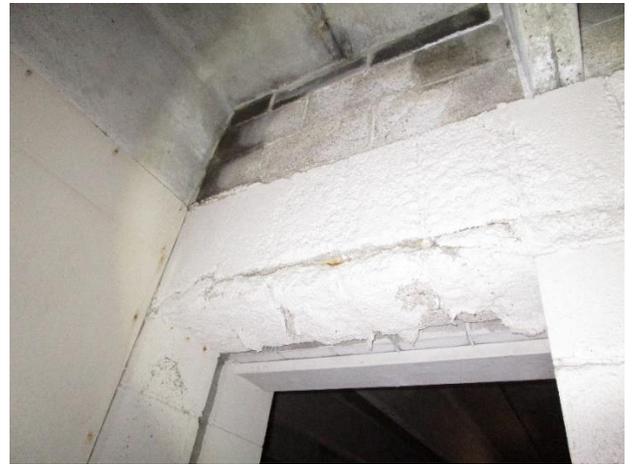
Photograph 20

- The bottom web of the CMU had separated at what appears to be the location of the reinforcement. There were rust stains visible inside the crack.
- Scaling was observed on the face shell above the bond beam and on the bond beam (Photographs 20-21).

Lintel at lower level doorway, bottom portion of CMU has separated.

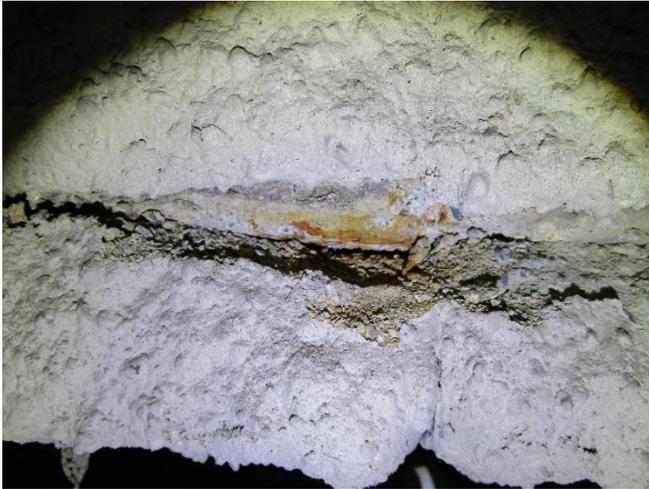
Photograph 21

Close up of photograph 17, rust stains visible.

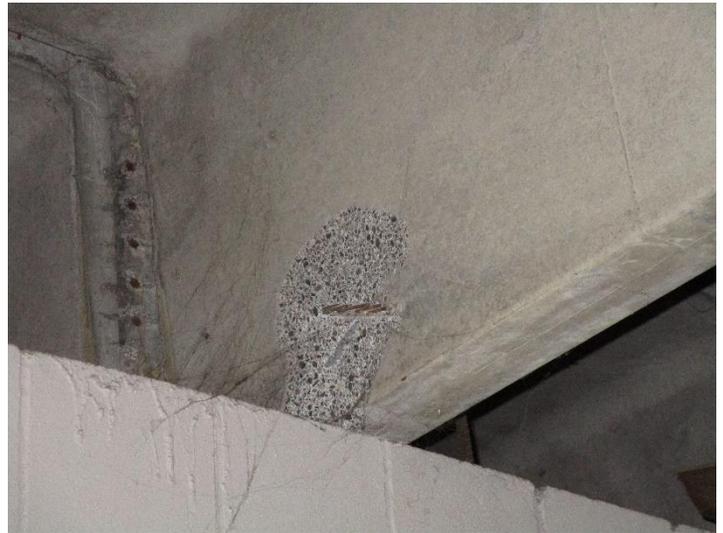
Photograph 22

- A spall was observed on a roof precast plank at a bearing location (Photograph 22).
- The exterior east wall had damage near the down spout (Photograph 23).
- Efflorescence observed on the CMU wall throughout the building.

Spall on a Roof precast plank.

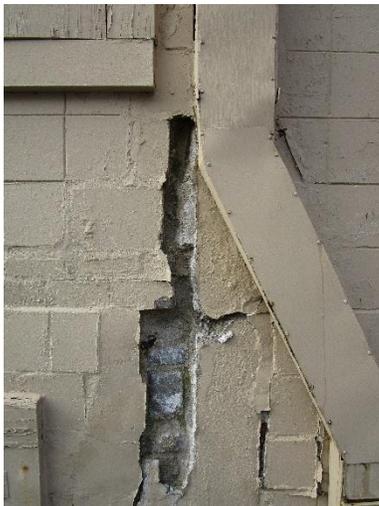
Photograph 23

East exterior wall, damage to the CMU wall at downspout

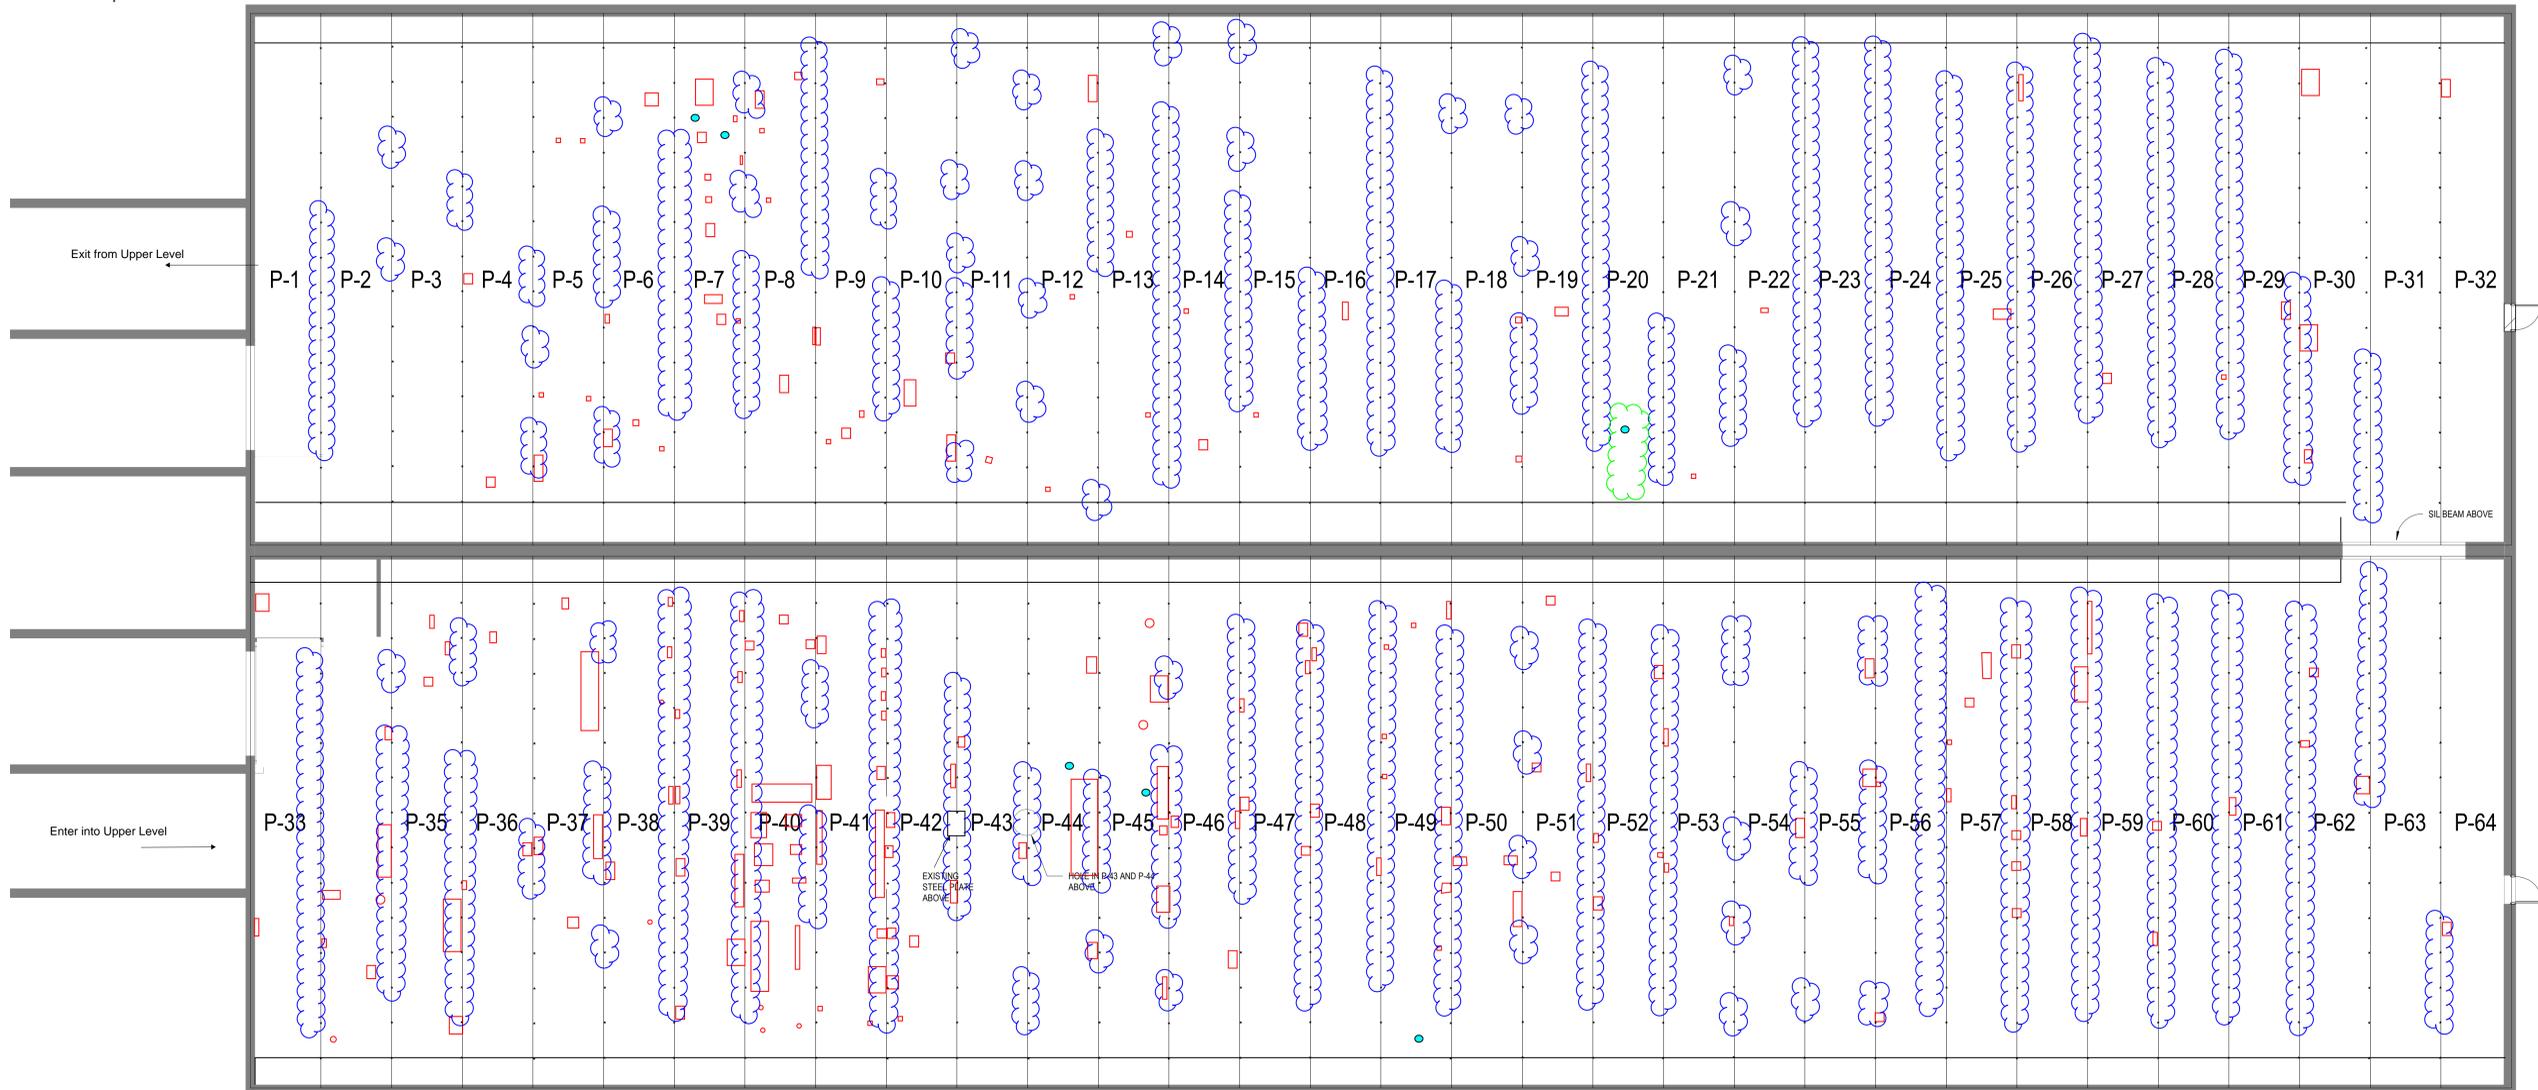
1 Level 1 R.C.P.
1/8" = 1'-0"

- NOTES:
1. LOCATIONS AND SIZE ARE APPROXIMATE
 2. MARKS IN RED ARE TOP SIDE DELAMINATIONS
 3. MARKS IN BLUE ARE UNDERSIDE VISIBLE DISTRESS
 3. MARKS IN GREEN ARE UNDERSIDE DISTRESS AT MIDDLE OF PLANK
 4. MARKS IN TEAL CORE LOCATIONS FOR CHLORIDE TESTING
