PALANISAMI & ASSOCIATES, INC.

RE: Parking Garage, 1010 Lake Street N.E. Hopkins, MN. Structural condition. PAI # 23041

Site observation:

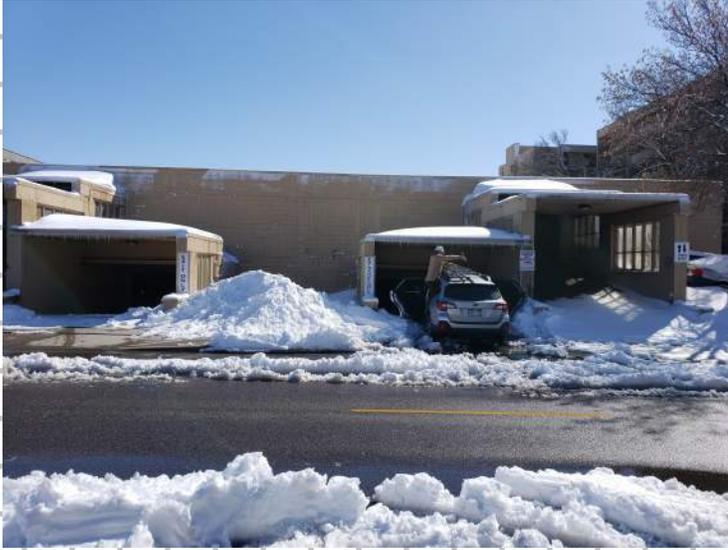
1. North face, entrance and exit

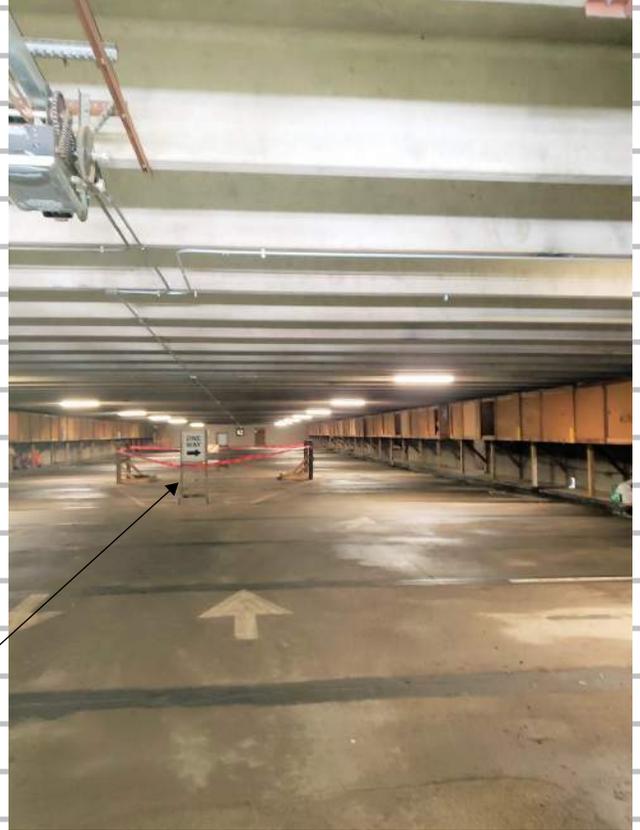
traffic blocked

2. West bay upper level. Looking South

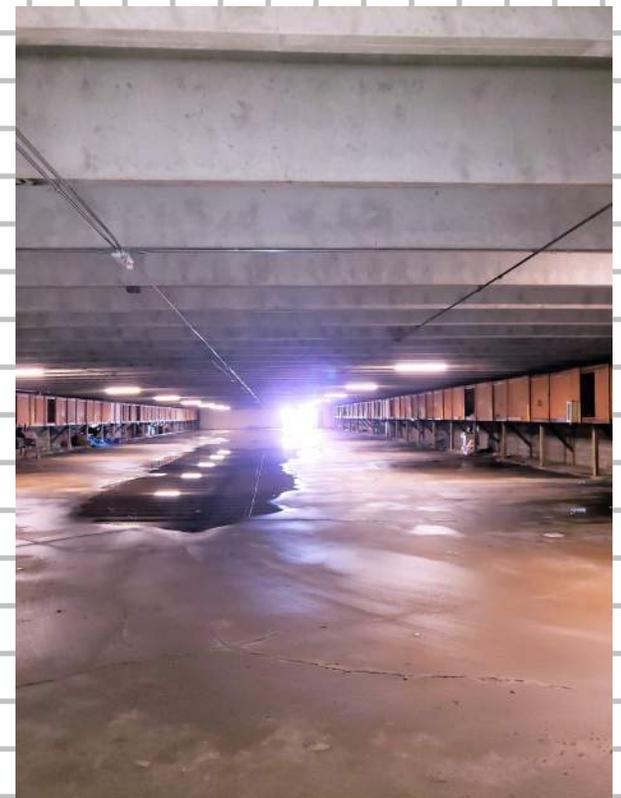
3. West bay lower level. Looking South

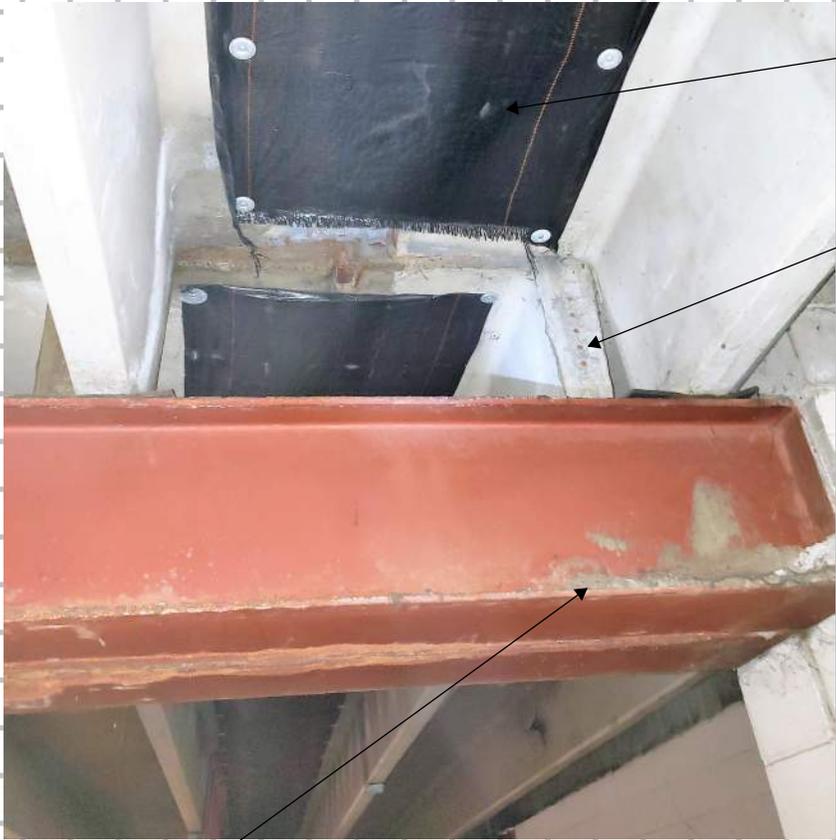
debris protection cover

prestressing strands

4. Steel beams at drive through south end west bay

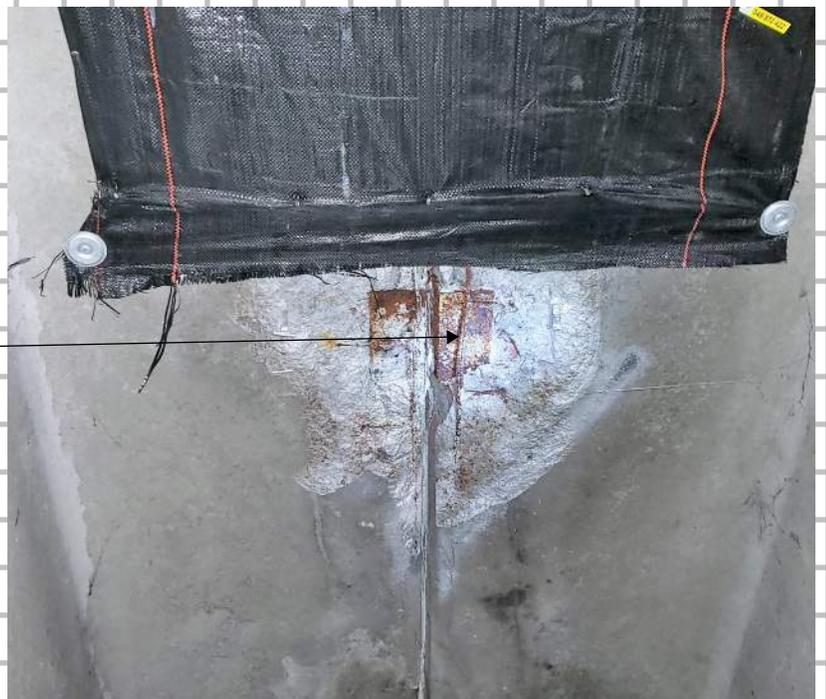
4. There are 32 slabs in each bay (31 joints) . 14 shear connectors in each joint. Total 868 connections. We estimate based on the rust stain and concrete spall below approximately 25% of the connections may not have full load sharing capacity of 2000 LBS.
5. The west bay drive isle is blocked off for traffic between 8th and 12th slab from north entrance. Steel plate covers an area roughly 5' X 5.
6. The flange and stem juncture of Tee slab is in good condition. The flange is functioning as cantilever from Tee stem.
7. No rust stem was observed in tee stem. The prestressing tendons within the stems are in good condition.

1. The primary issue is reduced shear connector capacity and needs to be restored.

5. typical shear connector. Concrete cover to embedded angle has delaminated. cause - Corrosion of angle. The steel slug is placed between the angles and welded to angle. West bay. West end. This condition is similar at other locations.

1. The concrete debris protection barrier below the joints shall remain until repair is done.
2. The traffic blocked out area at upper level shall remain until the repair is done
3. The repairs are to be completed in the summer of 2023.
4. The garage may be open for occupancy under monitoring at two weeks intervals until repair/construction starts.

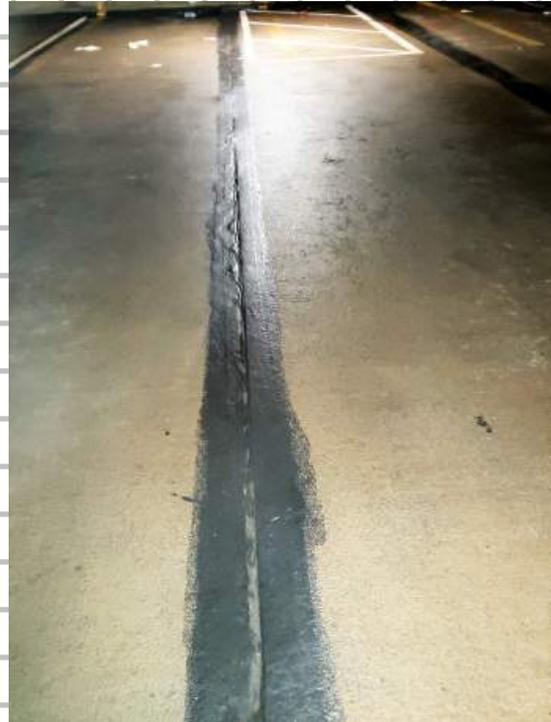
6. Tee slab joint condition. Top. The black material at top may be carbon fiber sheet reinforcing across joint or water proofing. Needs examination.

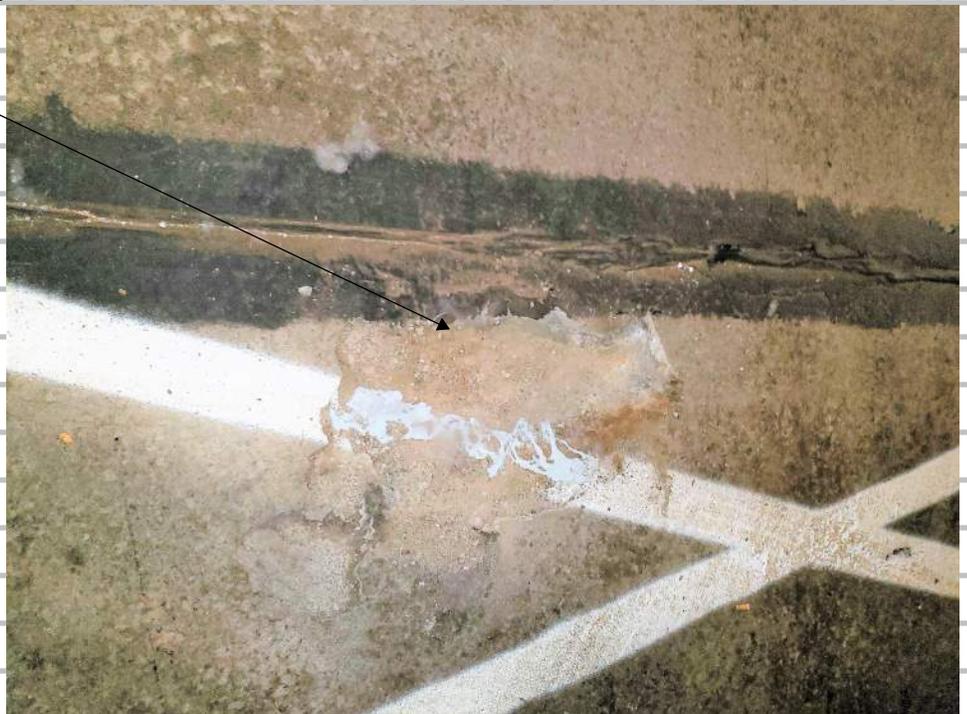
7. Traffic blocked off area. west bay
Top delamination
